Wetland Delineation

RMTII Samoa Effluent Pipeline Samoa, California

March 2017
015147.100

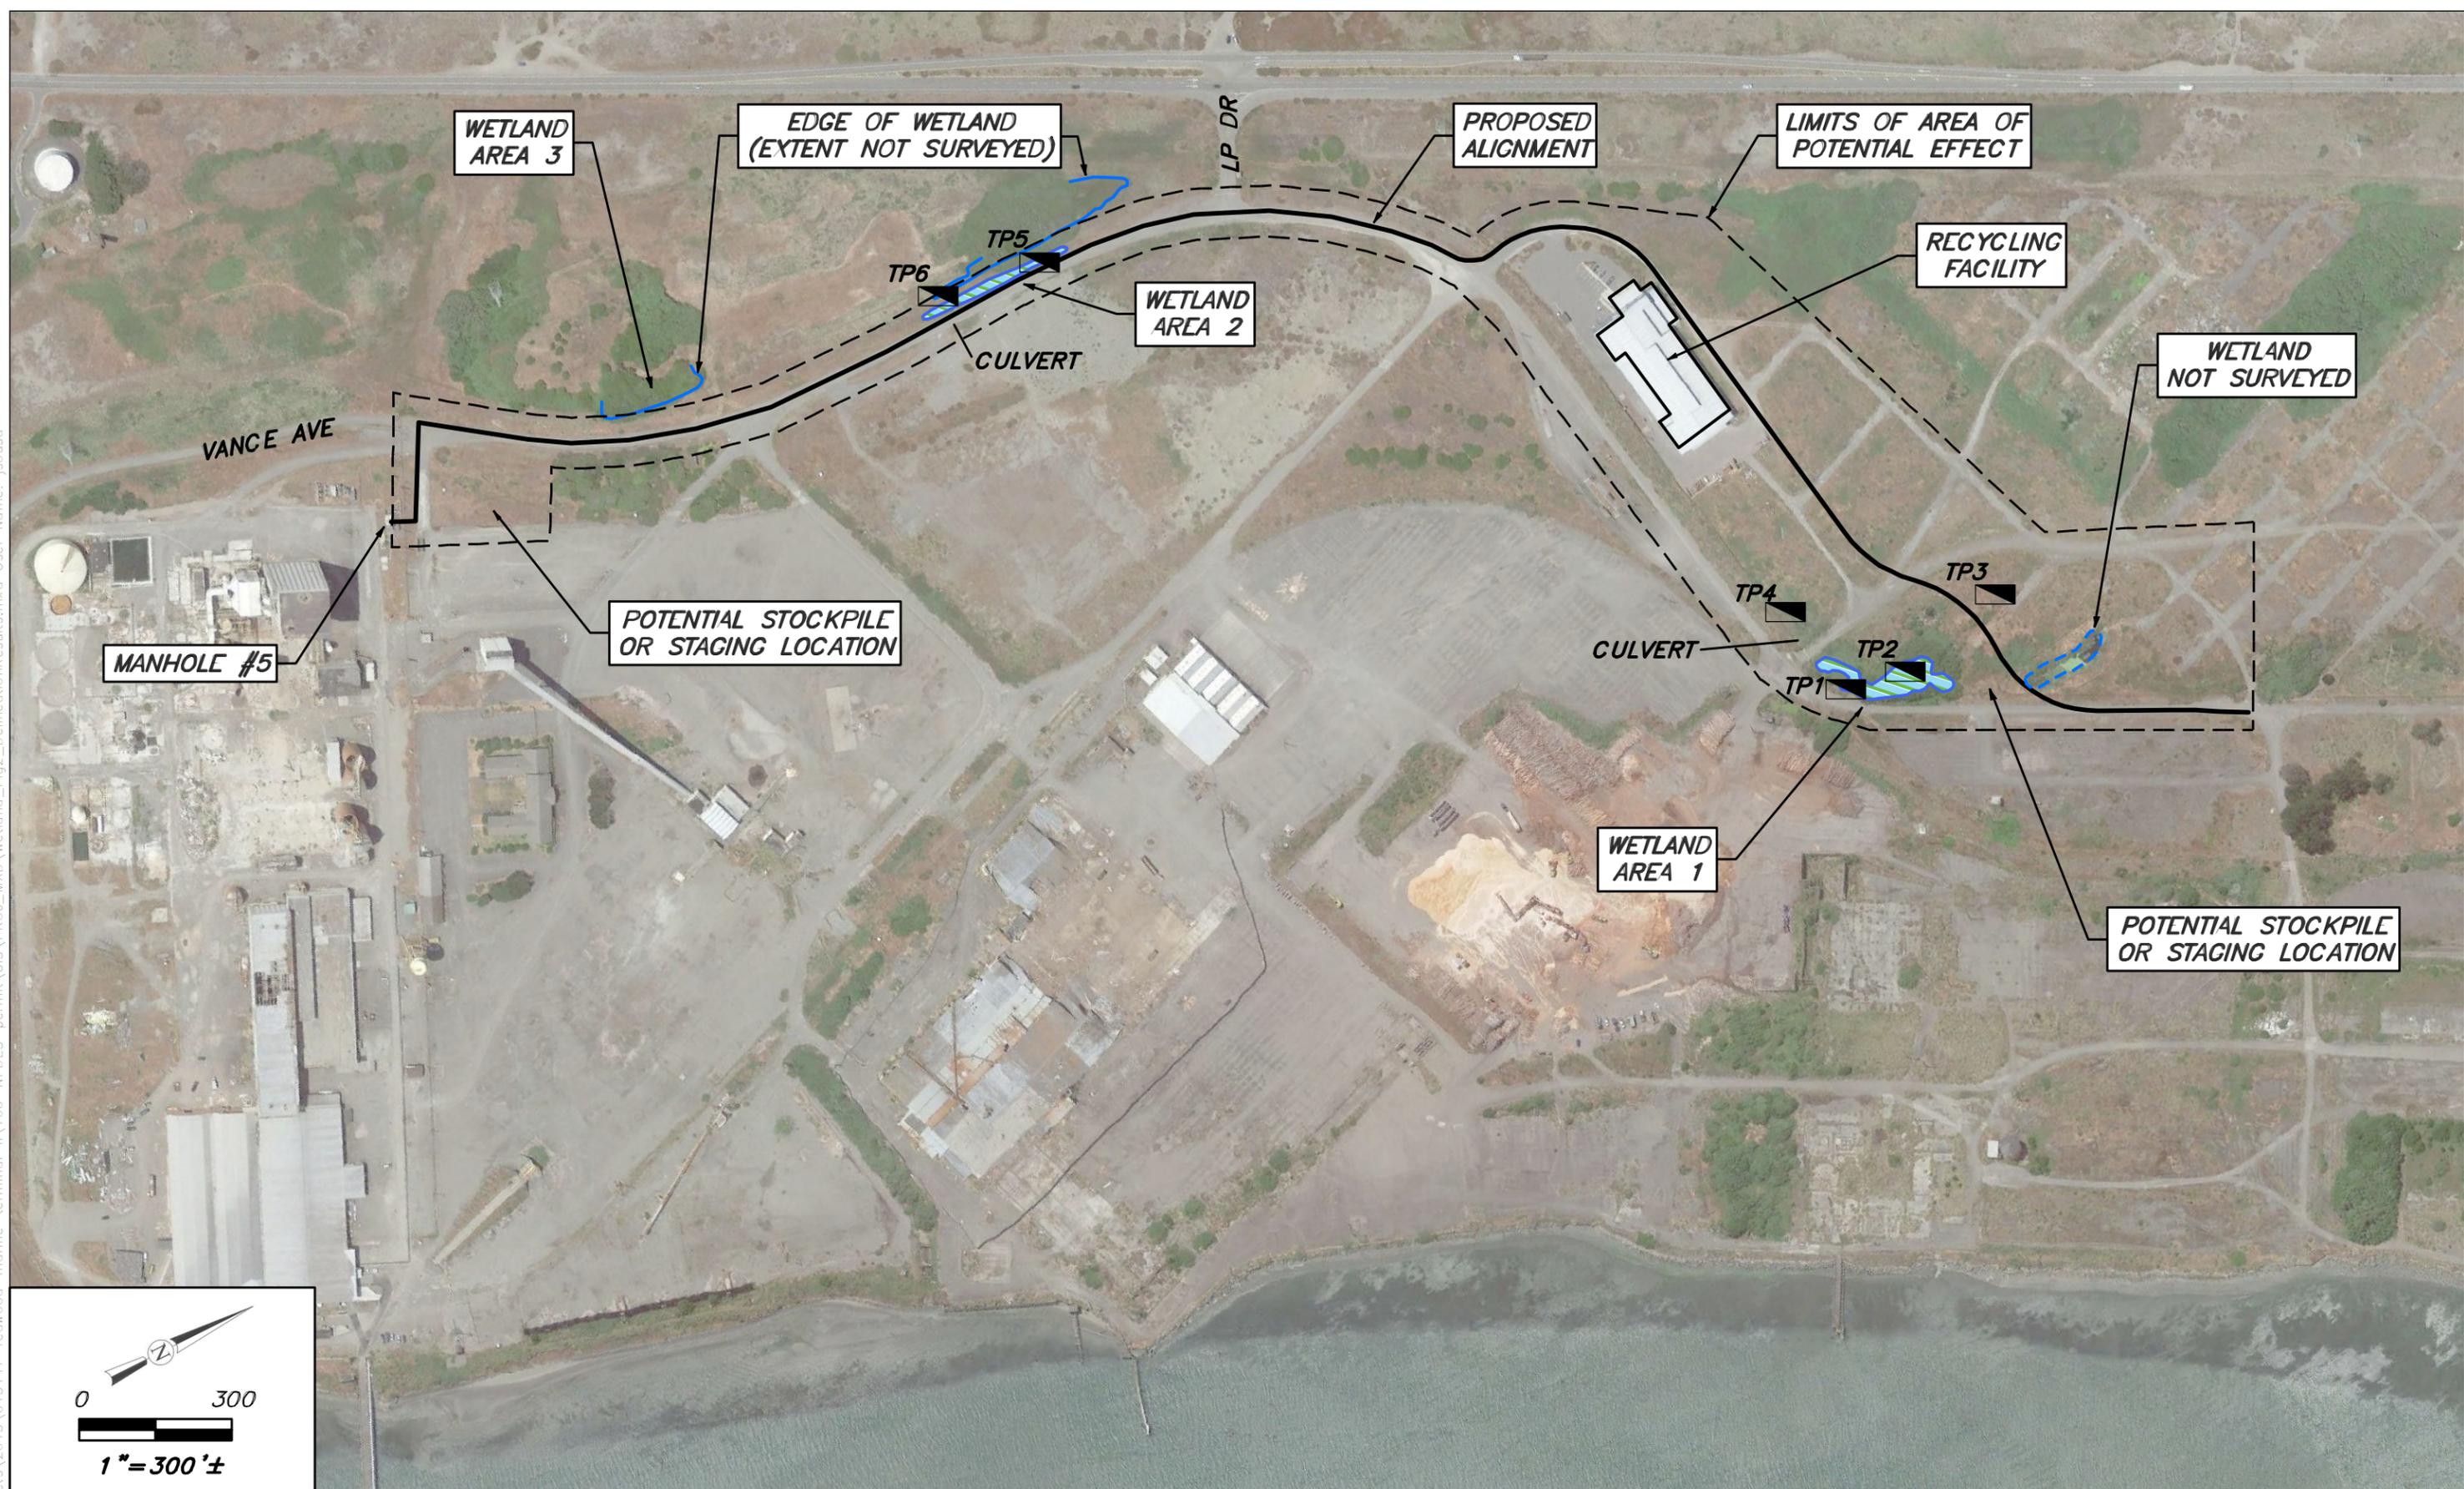
The study area is situated at an approximate 15-32 foot elevation above mean sea level (See Figures 1 and 2 and Appendix A). The study area has been used for industrial purposes since the 1960s. Several lumber mills operated on the northern portion of the site closing at different times within the last 20 years. These facilities have mostly been demolished leaving vacant industrial land. The southern portion of the project area has been the location of a pulp mill from the 1960s until 2008 when it closed. The area still contains structures from the shuttered mill; however, the majority of the site is composed of broad stretches of vacant asphalt with some small scale industrial use continuing on site. The western portion of the project area passes by an industrial recycling facility that will be skirted by the proposed effluent pipeline. Currently, the majority of the project area is covered in old asphalt, broken up concrete, compacted gravel within former log decks, and railroad infrastructure. Small areas of semi-natural dune habitat occur between the vacant industrial lands

TP6 is located in the southern portion of the study area to the west of the railroad tracks (Figure 2), and was investigated on March 24, 2017, following recent rains during an abnormally wet rainy season. TP6 is representative of the edge of the wetland to the west of the project area which receives the drainage from the wetland area represented by TP5. The railroad bed represents an abrupt edge to the wetland; however conditions were investigated to the west of the tracks to ascertain wetlands adjacent to the area of potential effects, and to analyze potential setback requirements. The area at TP6 was not as manipulated as TP5, although conditions were similar. TP6 represents the edge of industrial development and area of natural dune habitat between the railroad and New Navy Base Road. The area was mostly flat with a 0-1% slope preventing water from flowing quickly out of the area (See Figure 2 and Photo B7).

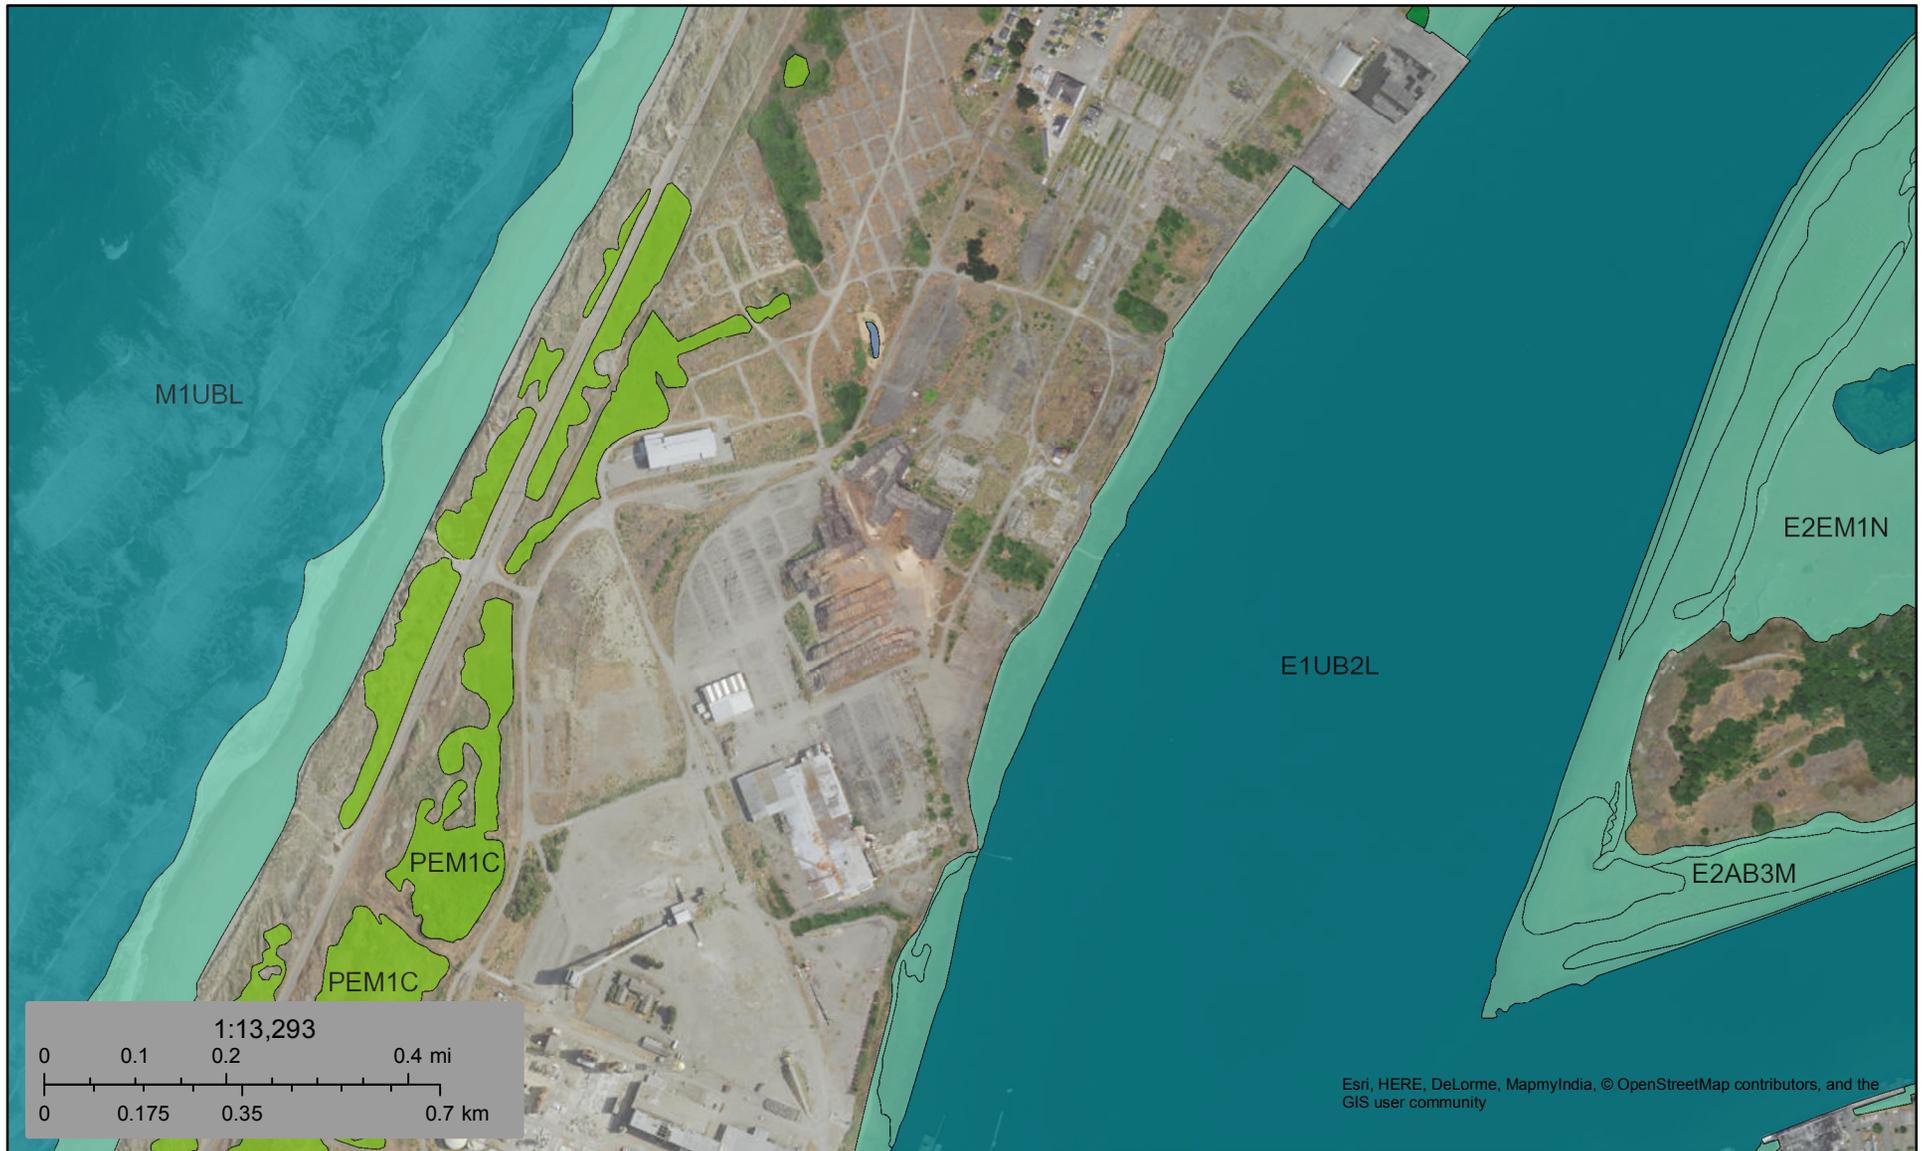
National Wetlands Inventory

The USFWS NWI website (Appendix A) shows freshwater emergent wetland (PEM1C) and excavated freshwater pond (PAB4Hx) NWI designation in the study area. While freshwater emergent wetland was found within the study area, the NWI mapping was found to be inaccurate during the site-specific analysis. Many areas designated as wetland by the NWI mapping were

found not to exhibit wetland parameters, primarily the area to the west and north of the recycling facility. The NWI map does reflect wetland conditions to the west of the project area within the southern portion of the project area. The wetland area represented by TPs 1 and 2 was not depicted on the NWI map, however wetland conditions were present. The area depicted as excavated freshwater pond does reflect conditions on the ground. The NWI map is a good tool for estimating wetland location, type, and extent for reconnaissance purposes, but must be confirmed by on the ground study and delineation. It is stated within the data limitation, exclusions and precautions page that the data contained within the NWI is to be used for reconnaissance level information of wetlands, and a margin of error is inherent with the use of aerial imagery in wetland determination (NWI Data limitations, Exclusions, and Precautions 2017).

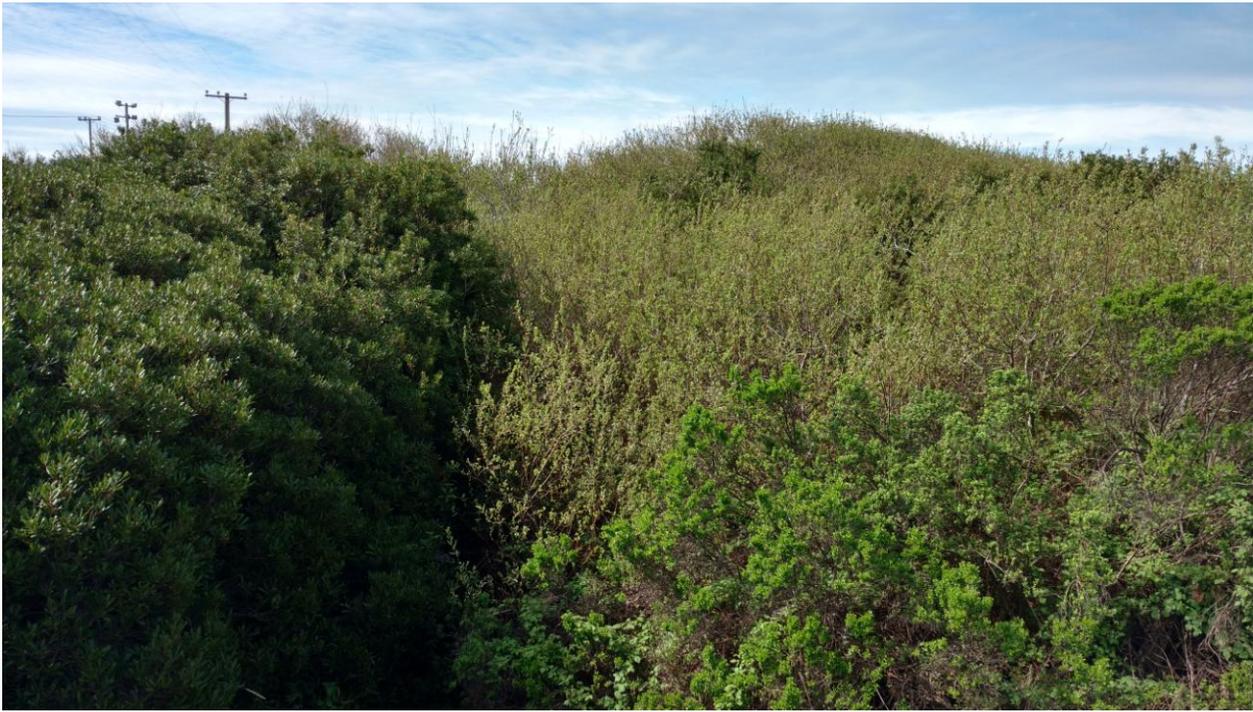
Photo B1: TP1 and TP2 Area, looking south. Note well developed dune willow and California wax myrtle canopy.

These pits represent three wetland areas delineated within the project area, and area of potential effects. The first wetland area, represented by TP1 and TP2 is approximately square feet and represents freshwater emergent wetland, within a relatively undisturbed isolated basin. The wetland within this location has a well developed canopy composed of dune willow and California wax myrtle, with a primarily native understory and shrub layer. The area represented by TP1 and TP2 represents valuable wetland habitat surrounded by heavily manipulated industrial development. It is recommended that this hollow be avoided during the project with an appropriate buffer to avoid potential impacts to the wetland habitat at this location.

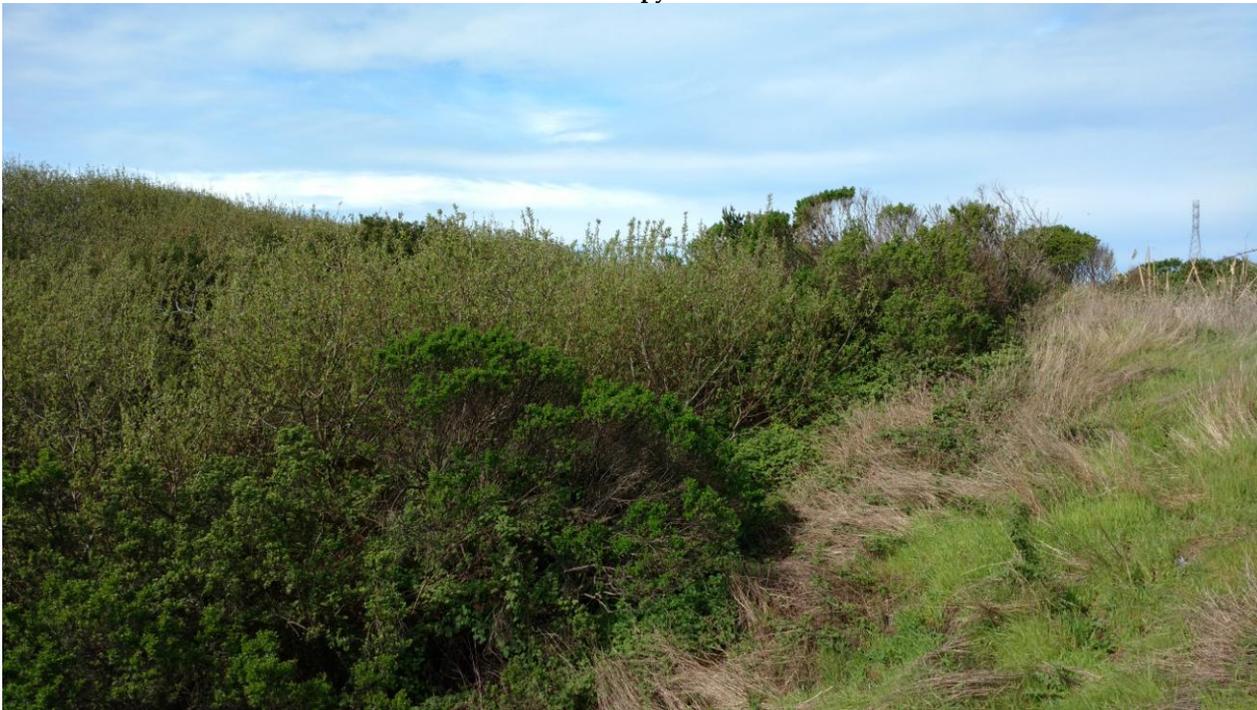
Photo B2: TP1 and TP2 Area, looking west. Note abrupt edge of willow canopy and beginning of disturbed industrial area characterized by non-native herbaceous vegetation.

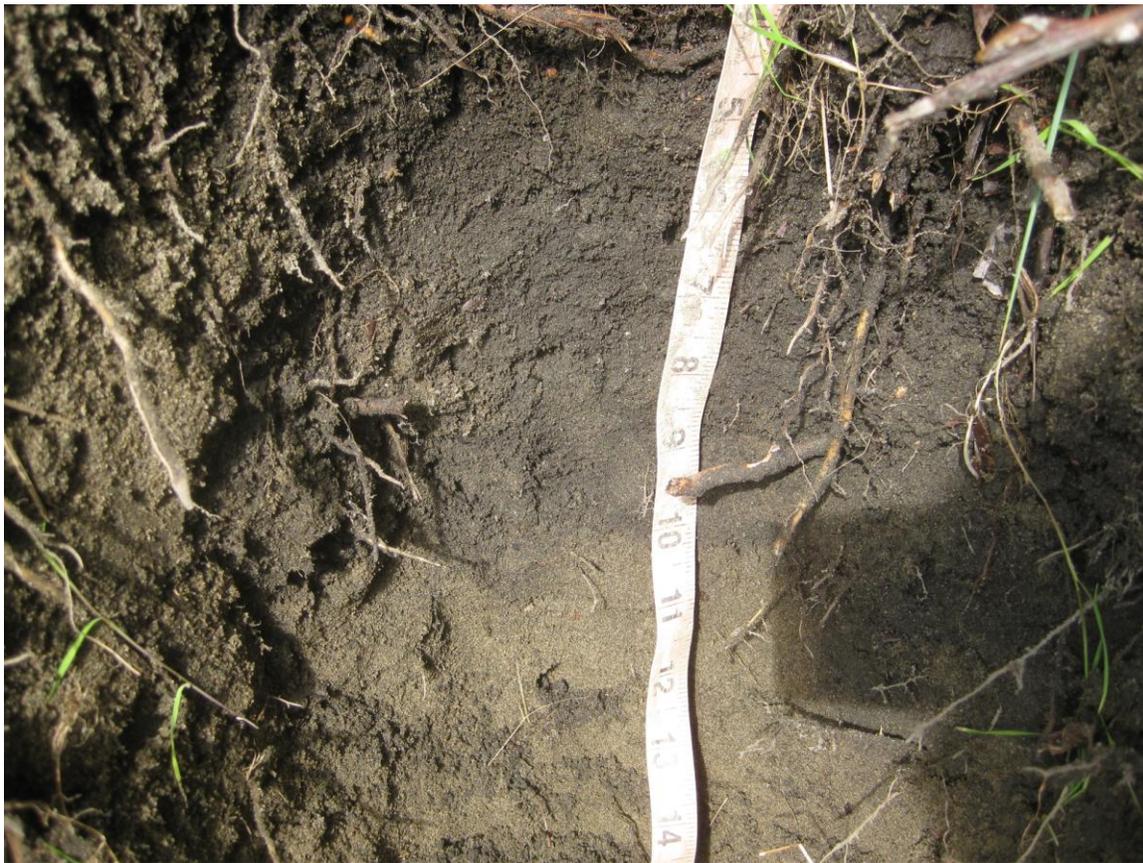
percent cover. Thirty eight percent of the area within TP1 was bare ground, a result of leaf litter, the nearby road base and a fire hose box. Hydric soils were present as evidenced by the presence of the black histic (A3) indicator. The hydrology parameter was not met at this site due to a lack of wetland hydrology indicators, even following abnormally high recent and seasonal rainfall amounts. Soils were sandy at this location, and well drained. Hydric soils may be a remnant from previous conditions, or a reflection of stormwater flows off of the expanse of asphalt, although a lack of flow patterns suggests this might not be the case.

Photo B3: Soil profile at TP1. Note black histic layer underlain by very loose sand. (Dark color of upper horizon somewhat lost due to direct sun and photo quality).

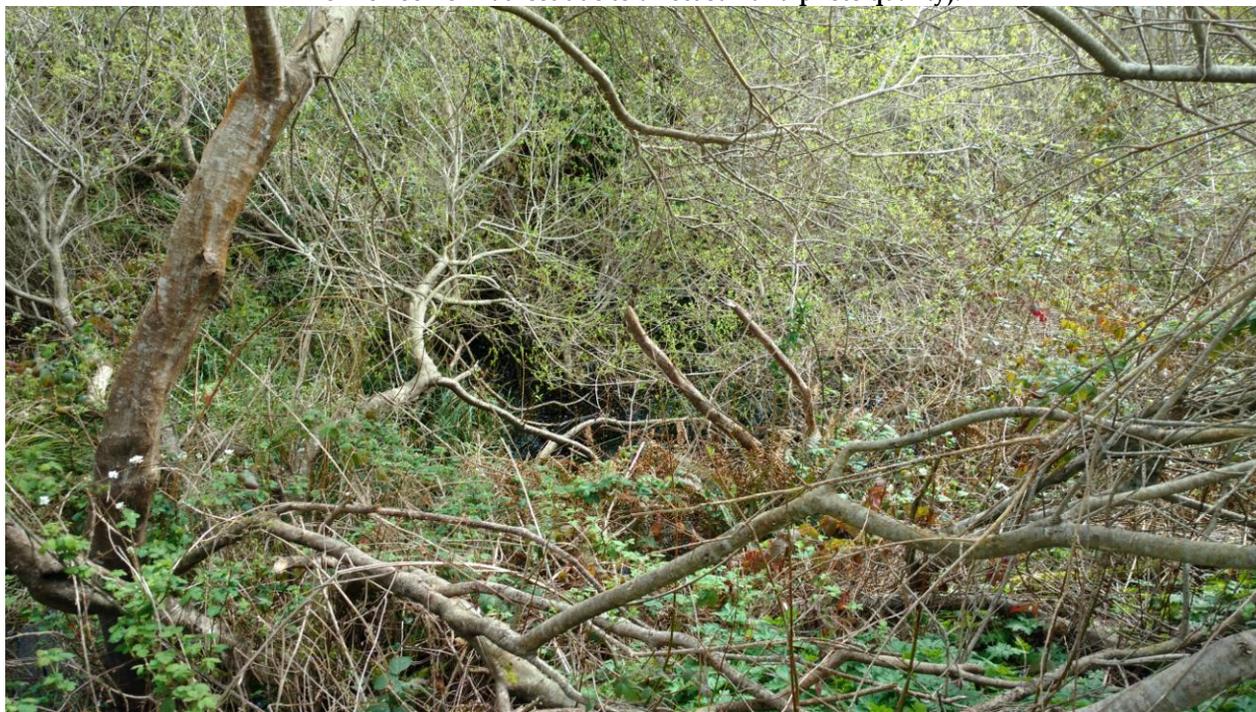
Photo B4: TP2 Site looking north beneath the canopy (3 parameter). Note pooled water in background (dark region), and dominance of the area by native vegetation.

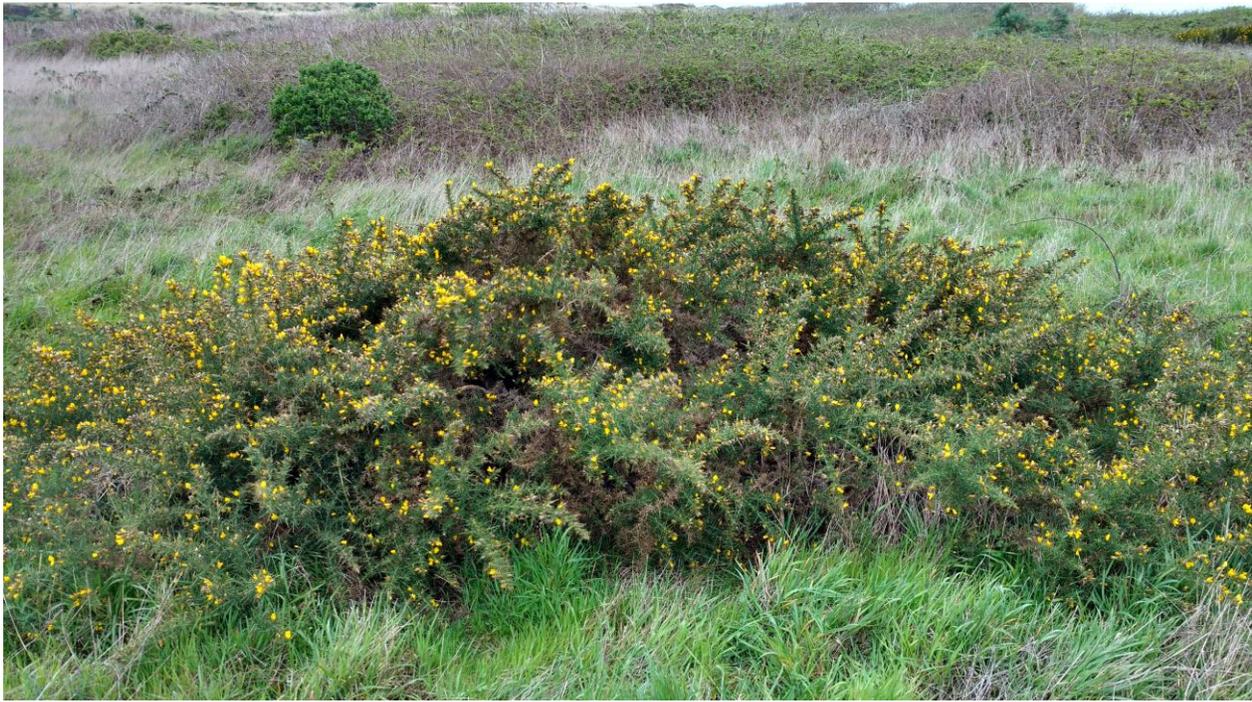
Photo B5: Region west of the Recycling facility. Note lack of wetland conditions and wetland vegetation. NWI aerial mapping mistook California blackberry thicket for wetland vegetation.

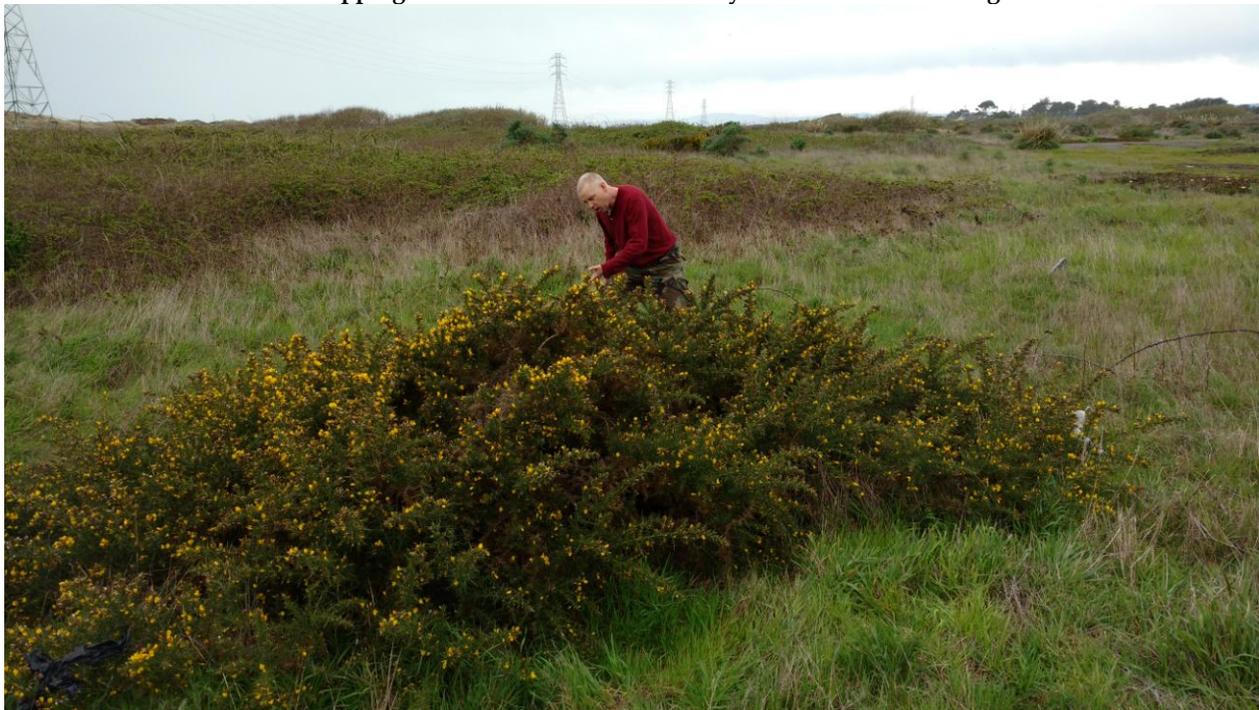
Photo B6: Region northwest of the recycling facility. Note lack of wetland conditions and wetland vegetation. Gorse in foreground extremely invasive, with great potential to invade surrounding land.

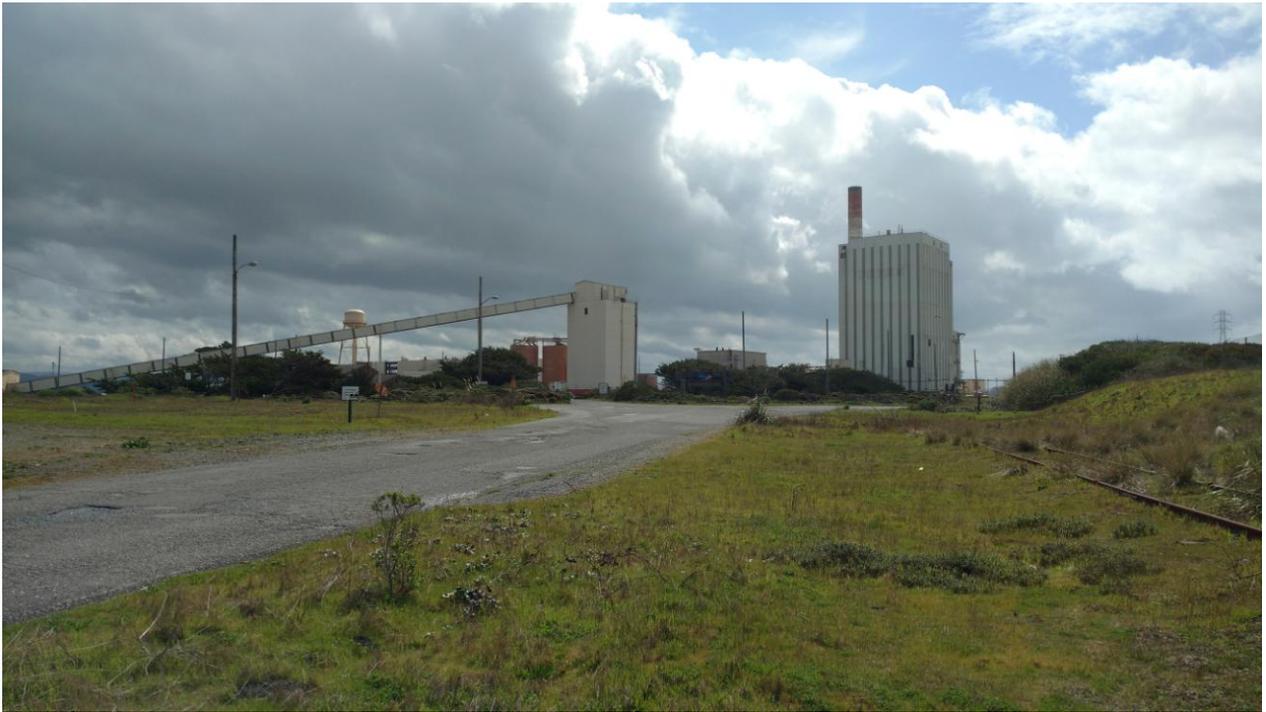
Photo B7: Southern study area, looking south. Wetland found along side Vance Avenue and Railroad, in vicinity of willow thicket on the right side of the photo.

The second wetland area is represented by TP5 and TP6. TP5 represents a wetland area between Vance Avenue and the railroad tracks that is hydrologically connected to the wetland represented by TP6 through a culvert under the rail bed. Conditions within the wetland at TP5 and TP6 are disturbed, as evidenced by an overwhelming dominance of the area by non-native species and invasive grass species. Stormwater from upland paved industrial areas to the east collect within in the depression between Vance Avenue and the railroad after passing through a culvert under Vance Avenue. Hydric soils, pooled water, and other wetland hydrology indicators indicate the edge of wetland due to the invasive vegetation being a poor indicator of wetland extent. It is recommended that the wetland represented by TP5 and TP6 be avoided during construction, however the lack of quality wetland conditions between the railroad and Vance Avenue may warrant reduced setbacks for the duration of the project. Willow dominated wetland beyond the fence line and area of potential effects represents high quality habitat and should be avoided.

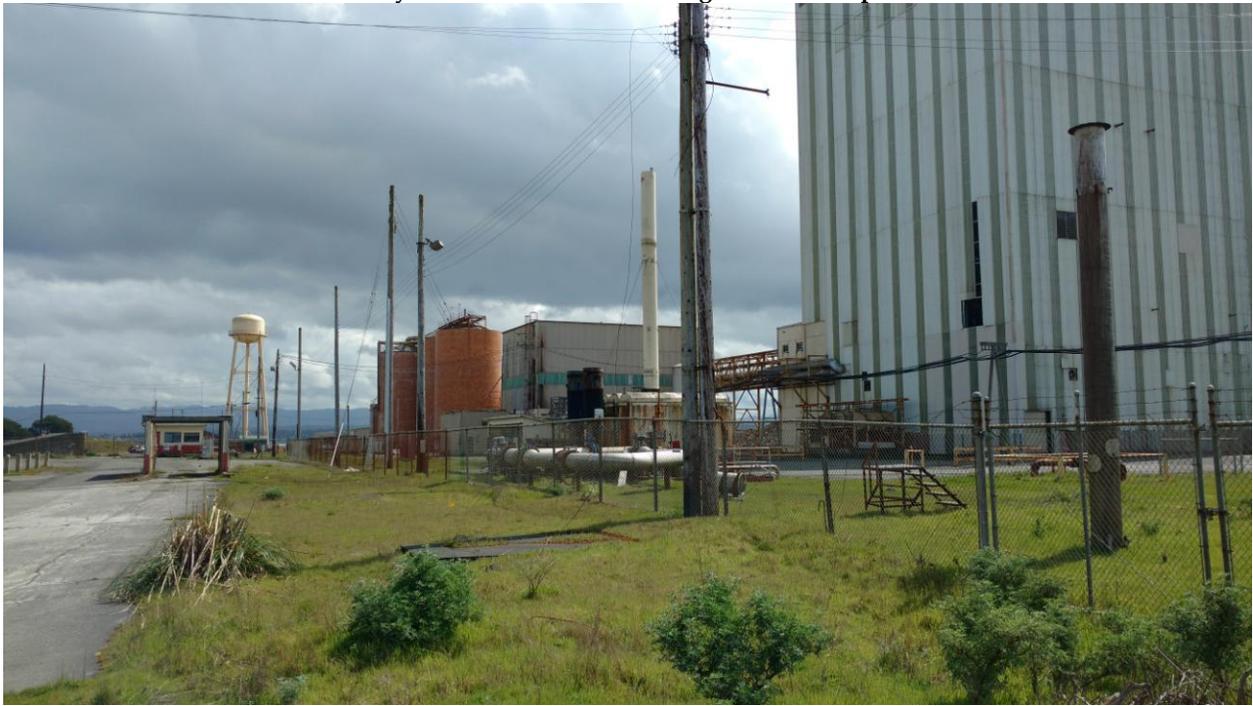
Photo B8: Southern terminus of the project area, looking east. Note dominance by upland vegetation, and lack of wetland conditions.
