Logging Road Assessment Report

Proposed Phase 1 Community Forest Acquisition, McKay Tract, Green Diamond Resource Company Property, Humboldt County, California

PWA Report No. 141006601
March 2014

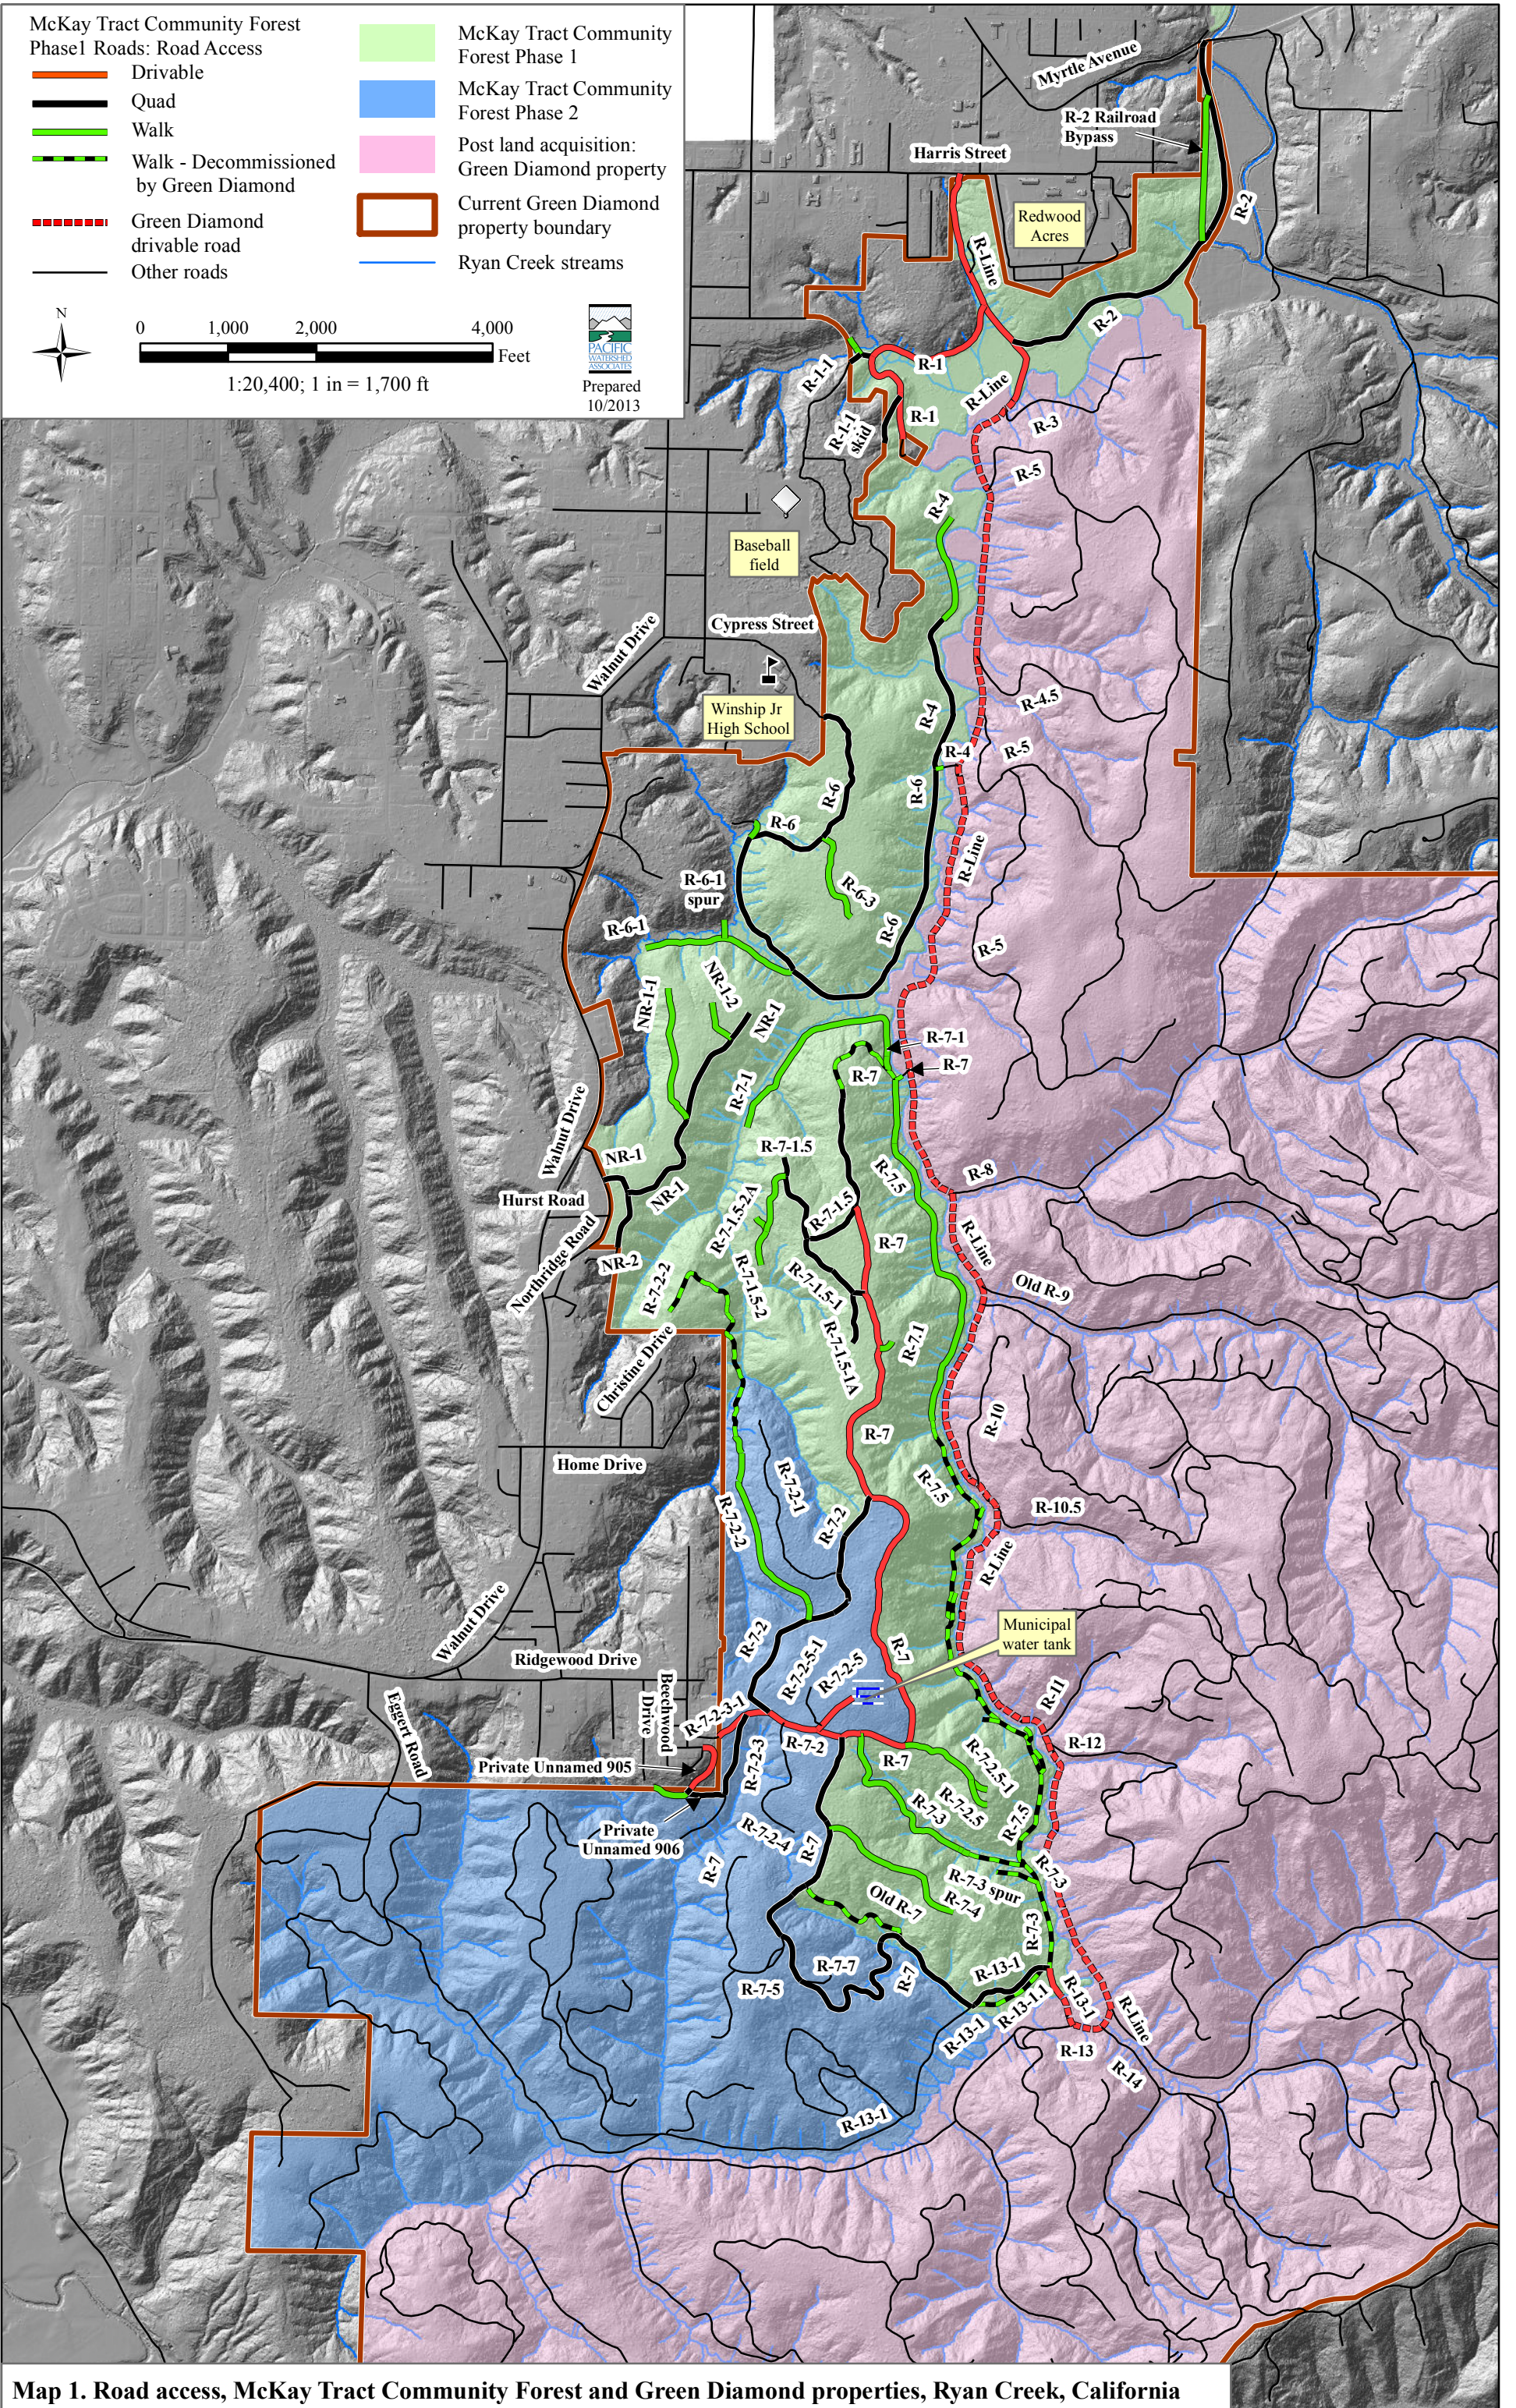
Description	Map #
Current road network and accessibility status	1
Sediment delivery sites by site type and treatment immediacy	2

A current road network and accessibility map has been included as Map 1. Map 2 identifies site locations by site type and treatment immediacy for the 17.2 mi of Phase 1 roads. These maps can be found in Appendix B attached to the end of this report. Assessment results and recommended treatments for the 17.2 mi of road within the Phase 1 acquisition area are summarized in Tables 1-5 located in Appendix A.

according to its treatment immediacy (Appendix A: Table 4a and Table 4b). Map 2 depicts the location, site type, and treatment immediacy for each site. Site-specific and road drainage treatments for the 227 sediment delivery sites recommended for treatment are summarized in Appendix A: Table 5.
