**HAZARDOUS WASTE  
INITIAL SITE ASSESSMENT/PRELIMINARY SITE  
INVESTIGATION**

**HONEYDEW BRIDGE REPLACEMENT PROJECT  
HUMBOLDT COUNTY, CALIFORNIA  
FEDERAL PROJECT NUMBER STPLZ 5904(024)**

## **Initial Site Assessment/Preliminary Site Investigation**

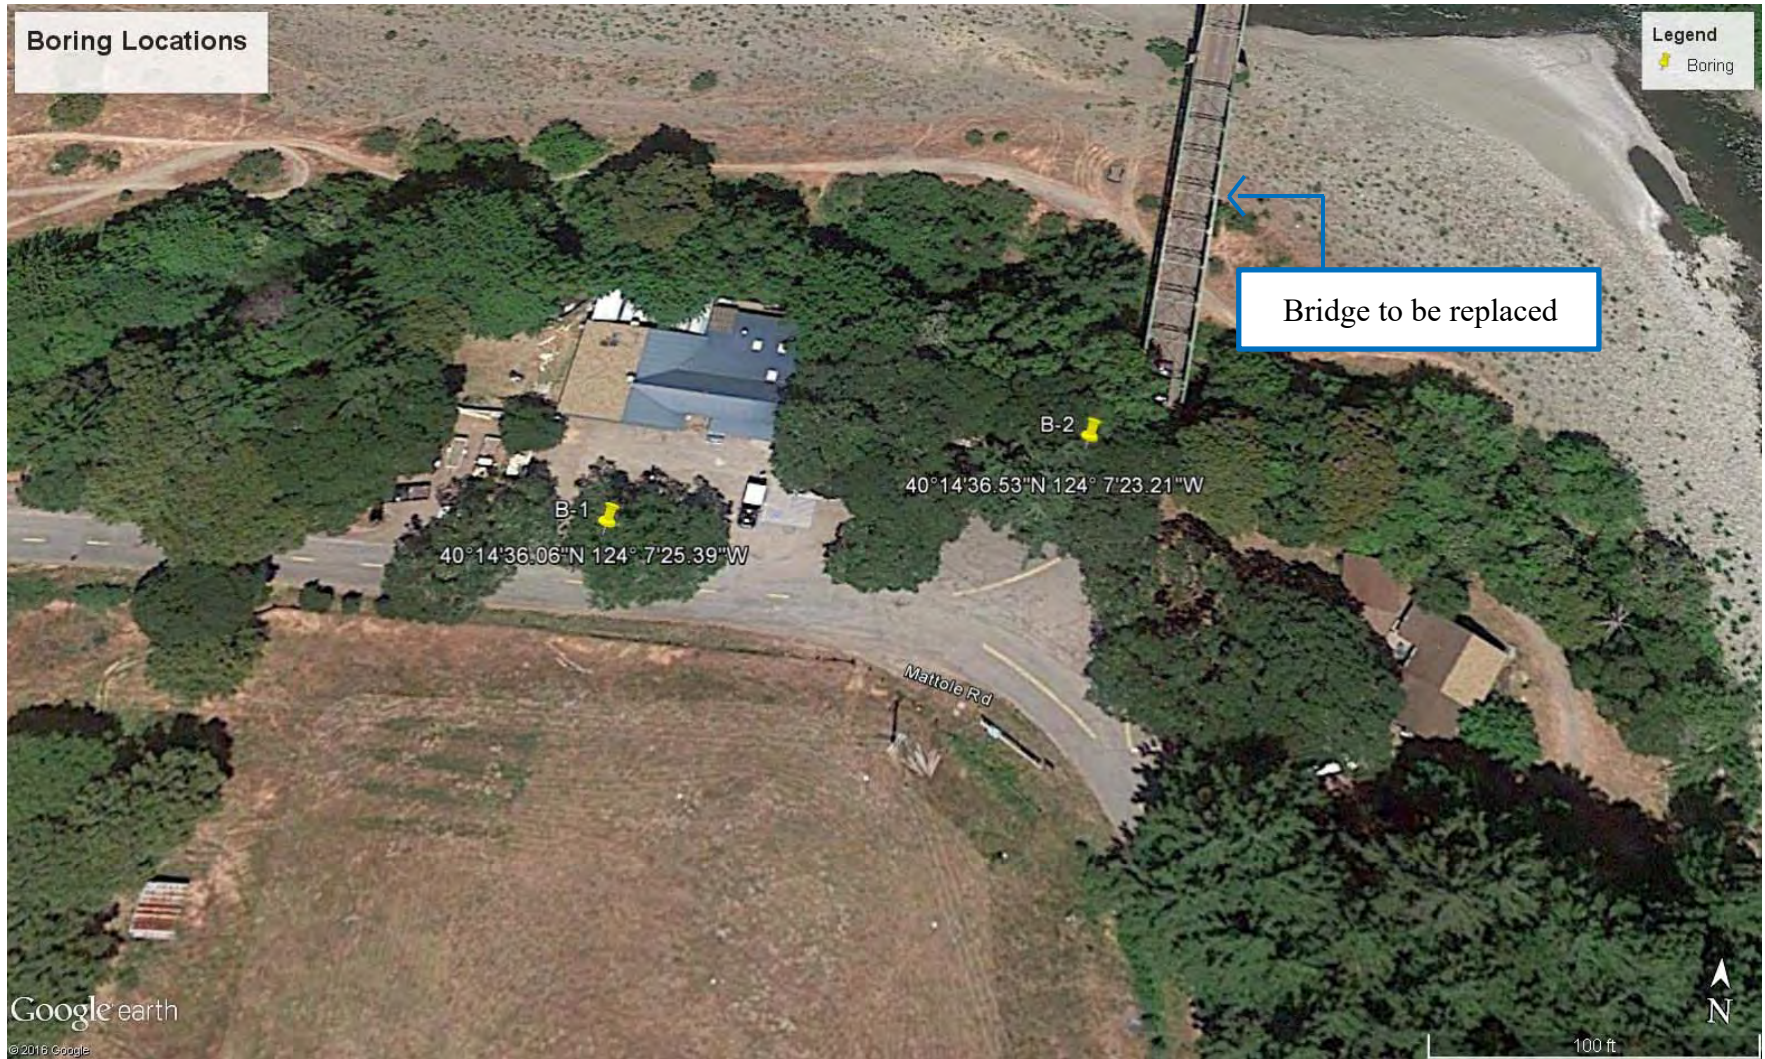
**Figure 9. Honeydew Bridge Proposed Soil Boring Locations**

After rocks, vegetation, and debris were removed from each sample location, each hole was hand augured to a maximum depth of 6 feet because of ground conditions. Representative composite soil samples were collected and homogenized from each augured hole from 0-5 ft bgs, and from 5-6 ft bgs; heavy gravel and clay were encountered between 5 and 6 feet bgs at both borings limiting further excavation. Groundwater was not encountered at either boring. Soil samples were sent to McCampbell Analytic, Inc for the analyses shown in Table 6 below. Field forms and boring logs may be found in Appendix L.

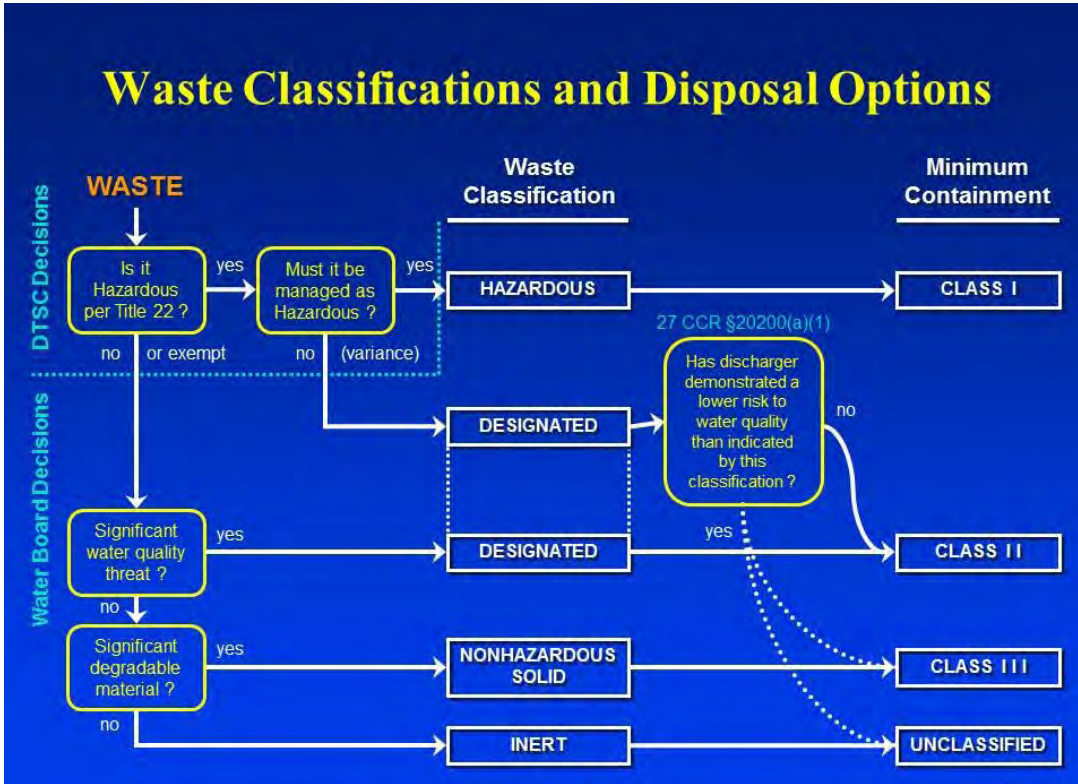
Figure 11. California Waste Classifications and Disposal Options

None of the three composite samples were reported with results above the threshold for the Resource Conservation Recovery Act (RCRA) or California hazardous waste. Consistent with CCR Title 23 disposal unit classification system (See Figure 11 below), WRECO recommends that the soil excavated from the Project area within the depth ranges (0 to 5 ft bgs and 5 to 6 ft bgs) sampled in the study be reused as inert soil.

WRECO recommends stockpiling excavated soils for waste screening and disposal unit classification during construction according to the pre-classification composite depth ranges screening results shown in Table 6 and Table 7; WRECO also recommends practices associated with the CCR Title 23 stockpile screening requirements.

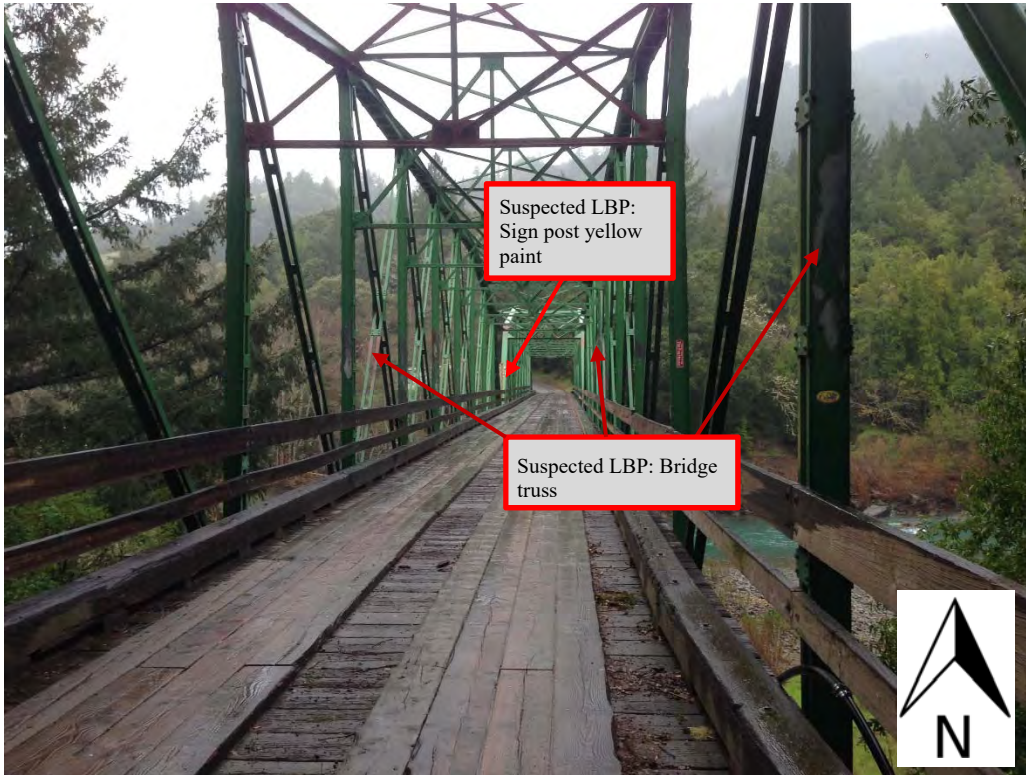
**Figure 12. Lead-Based Paint Sampling Locations**

Paint chip samples of a size representative of the surface of interest were collected and recorded in the inspection field forms (Appendix L). Each sampling location was logged with photographs, a description of the location and material, approximate estimated quantity, and sample volume. Lead-based paint was suspected for paint on the bridge truss, wooden signs post paint, roadway paint striping, and the abandoned boat underneath the bridge. Figure 12, Figure 13, and Figure 14 show the locations of suspected lead-based paint and locations paint chip sampling was performed. Paint identified in the roadway striping is presumed to contain lead at hazardous levels due to color, age, and industry practice.

Paint from the truss of the bridge exceeded the regulatory threshold for LBP (< 0.1% concentration). To most accurately assess the bridge's painting condition, three sampling locations were taken (LBP-1, LBP-2, and LBP-4) and were all over 0.1% concentration. All paint on the truss is considered California hazardous waste and requires adherence to hazardous waste regulation during abatement prior to construction.

WRECO recommends LBP be abated prior to planned construction/demolition. Abatement must be performed by a licensed contractor in accordance with 17 CCR 3500 et seq.

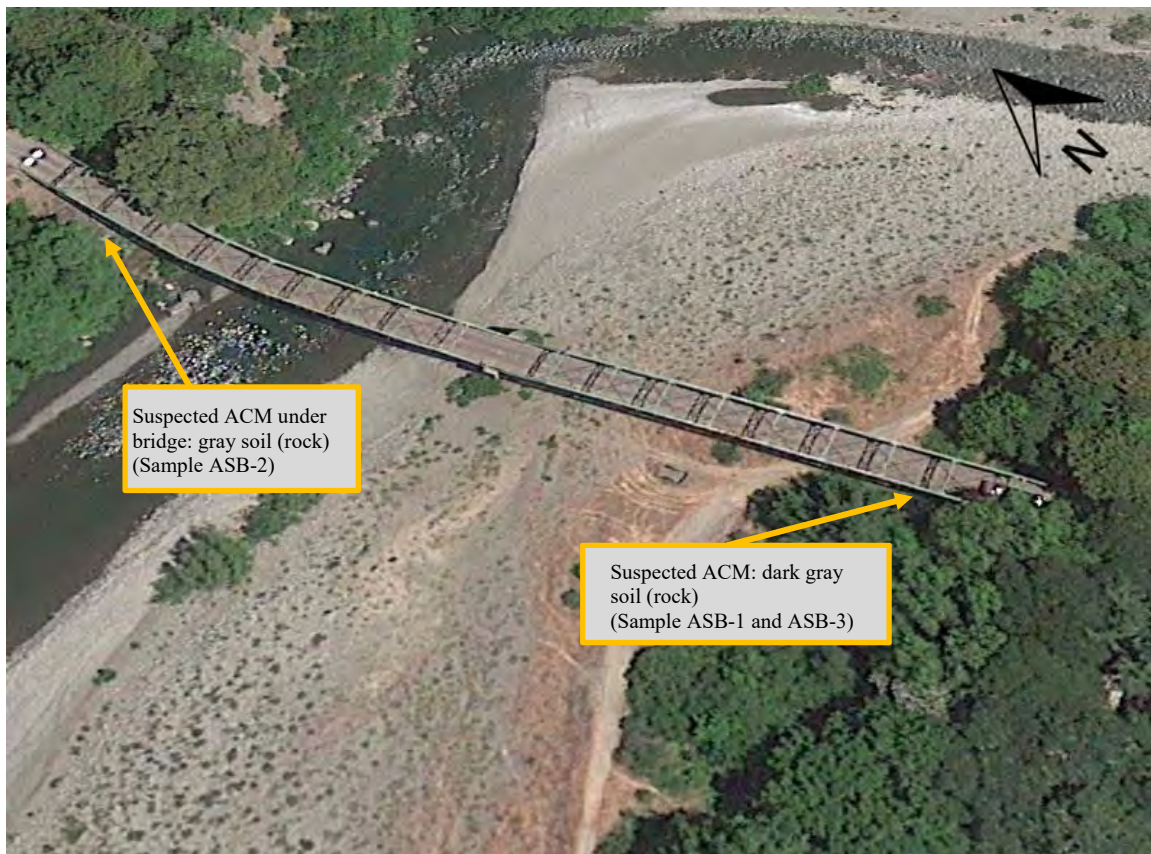
**Figure 15. Asbestos Sampling Locations**

Figure 15 shows the locations for asbestos material sampling and Table 9 shows potential material classification.
